Survey of the Canton Battery Site, Waipori, Otago

Francesca Allen, Baylee Smith, Jessie Hurford
University of Otago Anthropology Society

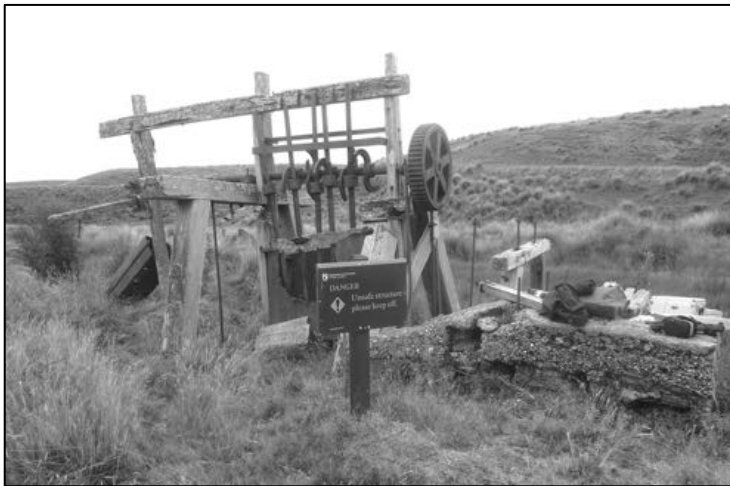
Figure 2. The Canton Battery in 2016 (Hannah Arnhold).

As the purpose of the site survey was to undertake a more thorough investigation of the surroundings of the Canton battery and water wheel they shall only be briefly described here (for a more thorough description see Petchey 2014 & 2015). The Canton battery is a five stamp mill, but it was built using the camshaft for a larger ten stamp mill. There is no evidence to suggest that the full ten stamps were ever fitted as there is no damage to the camshaft where the extra five stamps would have been mounted and the timber guides are only grooved for the existing five stamps. The mill has a trestle type frame with a heavy timber trestle structure to support the camshaft. Only the centre trestle remains completely intact. The mortar box is a one-piece cast iron item. The projecting flange around the screens and the apron has been broken away and the makers place is also missing. At 63 inches long this is the longest mortar box recorded in New Zealand (Petchey 2013: 208). The Canton water wheel has deteriorated significantly in the past twenty years, being relatively intact in 1995. The wheel is half buried in its original position, on the edge of the Pioneer Stream, with four surviving exposed spokes and a small portion of the shroud visible.

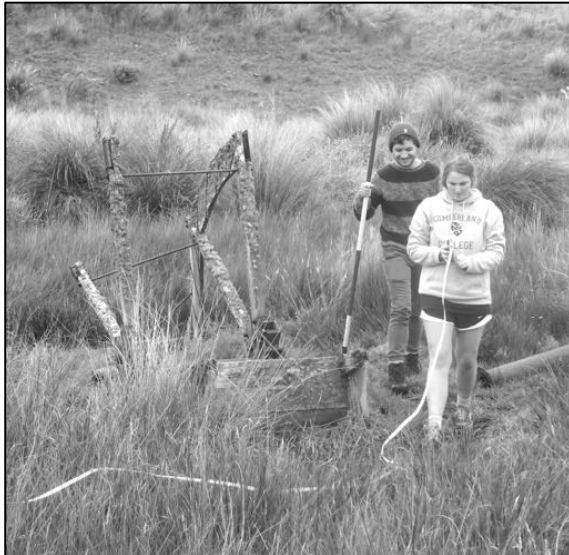
Figure 4. Working around the remains of the Canton water wheel (Hannah Arnhold).

namely the partially buried water wheel (Figure 4), were then mapped. Although infilled (or collapsed) the shaft was still easily identified as a rectangular depression in line with the water wheel, with several upright timbers and vertical iron rods from the shaft head structure still in place. As
